**Flood Control Project Maintenance
Levee Inspections****LMA District Cover Sheet****Spring 2014 Levee Inspection Results****American River Flood Control District**

Spring 2014 Levee Inspection Results

American River Flood Control District

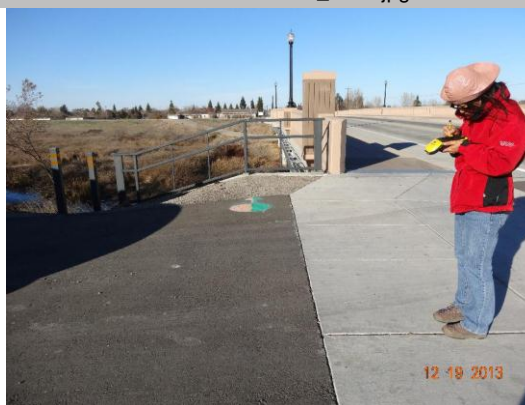
Photo 1 of 1 : UCIP_6314.jpg

Indicator of crossing found on waterward side edge. Symbol is a Flood Control Structure (green/orange circle).

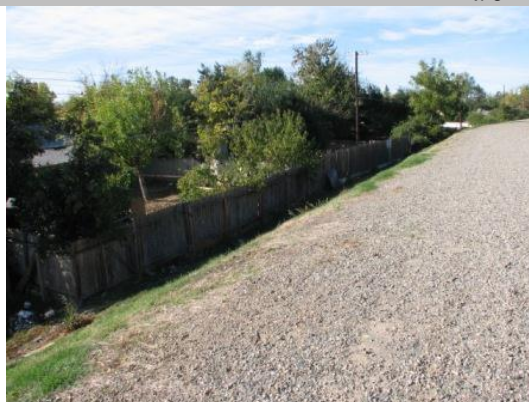
Photo 1 of 1 : mkhashch_s_20140428_00017.jpg

Photo of solid fences built against the levee slope.

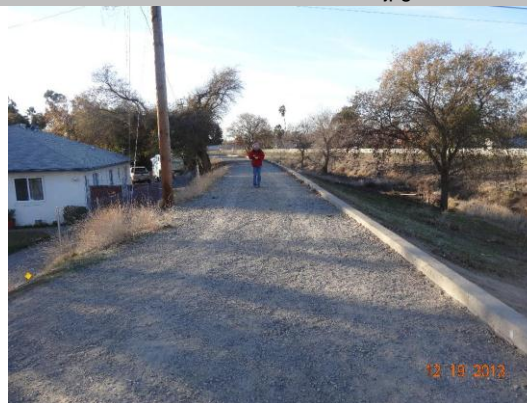
Photo 1 of 1 : UCIP_6316.jpg

Overall view of levee crown looking downstream from approximately 100 feet upstream of crossing.

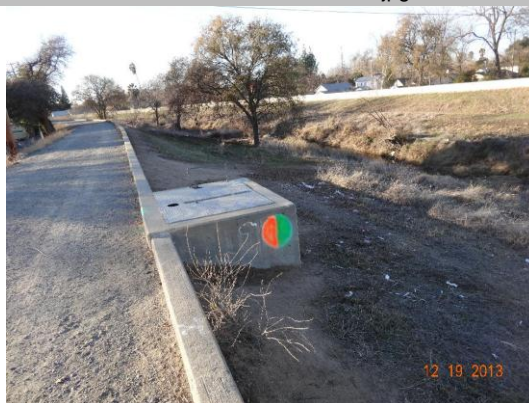
Photo 1 of 1 : UCIP_6328.jpg

View of concrete vault located on waterward apex.

LM Start	1.58	Rating **	A/W	Issue No.	174
LM End	1.58	Issue Type +	Ma	Location *	WS
Category	Earthen Levee			GPS Latitude/Longitude	
				Start	End
Item	Encroachments			38.627244 °	38.627244 °
				-121.441462 °	-121.441462 °
DWR ID	DWR_NA0001_01_s_2012_174				
Action/Comments					
Pipe					
Inspector Comments: Flap gate appeared to be closed.

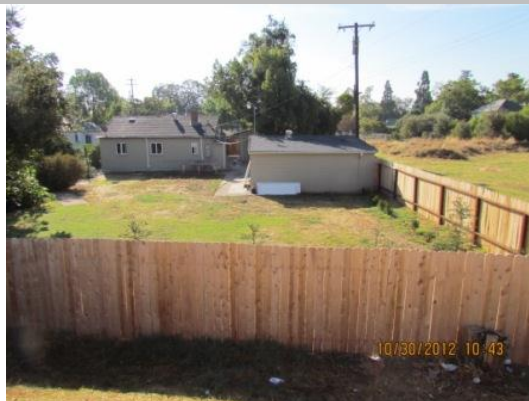
Photo 1 of 1 : mkhashch_s_20140428_00009.jpg

View of new fence constructed at levee toe and 7 redwood trees planted behind fence within easement.

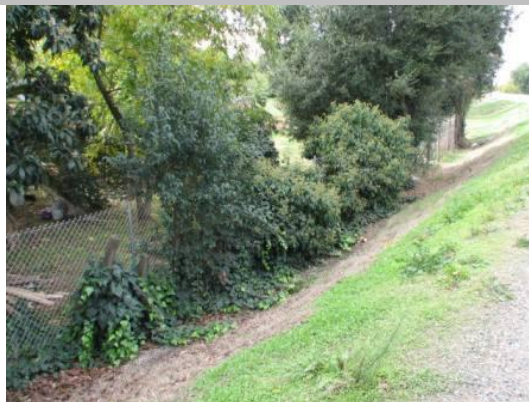
Photo 1 of 1 : mkhashch_s_20140428_00039.jpg

11/17/2011 Growth on existing wooden fence is obstructive.

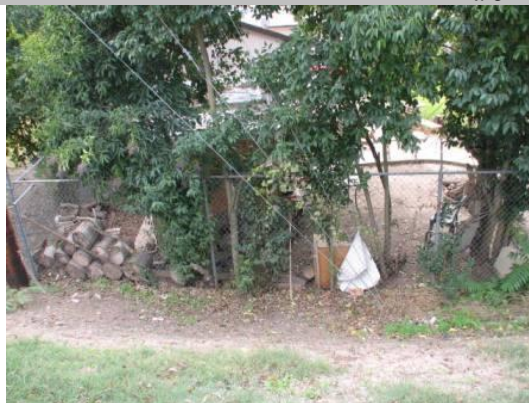
Photo 1 of 1 : mkhashch_s_20140428_00027.jpg

11/17/2011 Wooden structure is built within 15' of the levee toe.

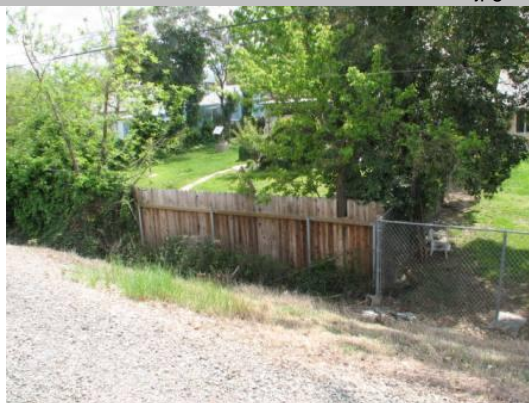
Photo 1 of 1 : mkhashch_s_20140428_00008.jpg

04/13/2011 Portion of fence has been replaced, assume that this is the portion that fell down and was referenced in the fall '10 inspection.

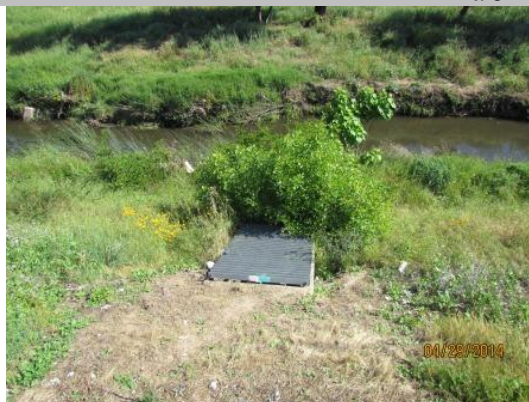
Photo 1 of 1 : mkhashch_s_20140505_00951.jpg

View of the vegetation obstructing the outfall.

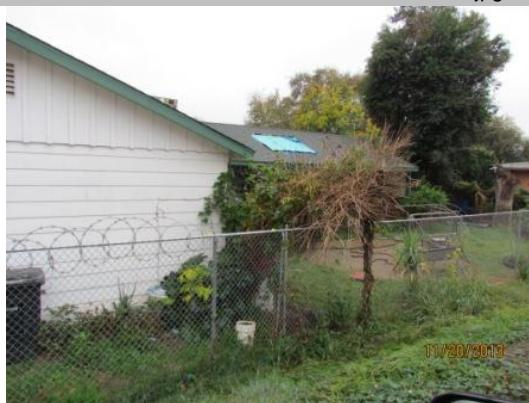
Photo 1 of 1 : mkhashch_s_20140428_00001.jpg

View of the fence and landscaping at the landside levee toe.

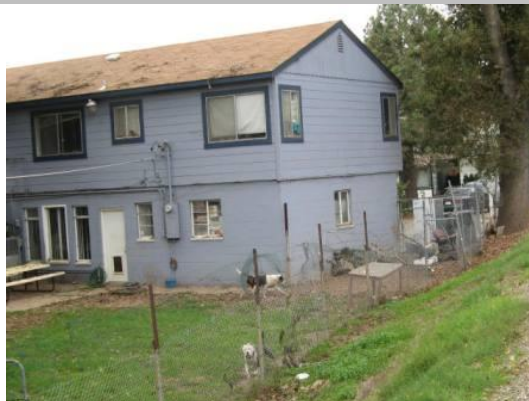
Photo 1 of 1 : mkhashch_s_20140428_00023.jpg

11/17/2011 Building foundation is within 15' of the levee toe.

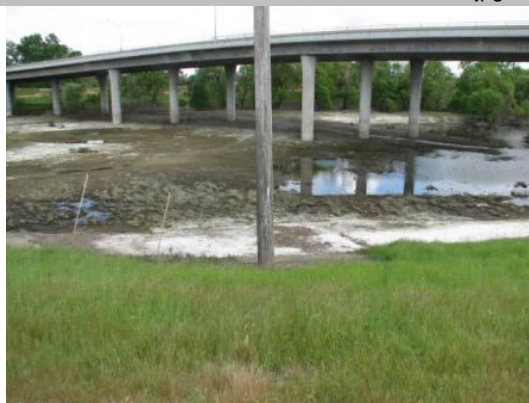
Photo 1 of 1 : mkhashch_s_20140428_00054.jpg

04/13/2011 Power pole is in the levee on the water side.

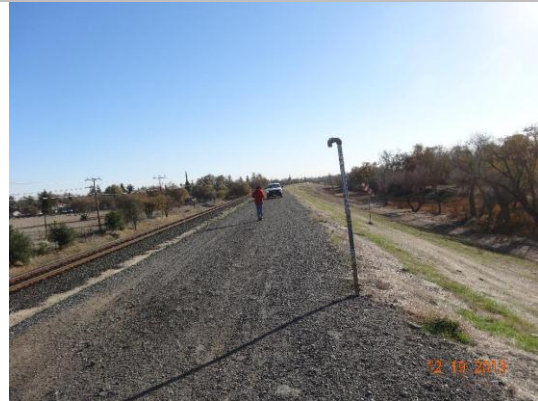
Photo 1 of 1 : UCIP_6262.jpg

Overview of levee crown with utility gas markers on waterward side.

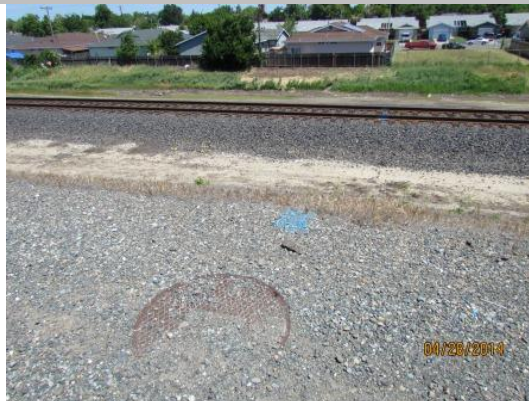
Photo 1 of 1 : mkhashch_s_20140505_00944.jpg

View of the pipe from levee crown.

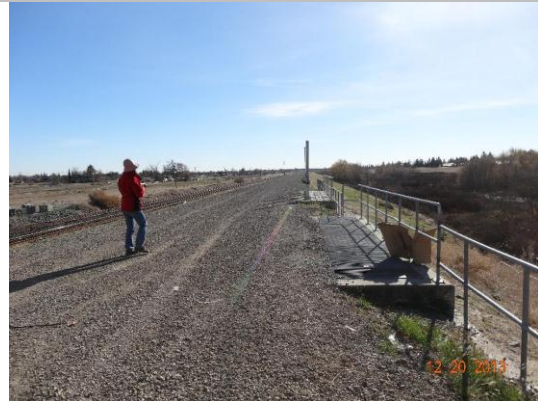
Photo 1 of 1 : UCIP_6155.jpg

Action/Comments					
Inspector Comments: FS_ID:28724					
EP_NO: 9596					
Repair Type:					
Crossing Status:					
UCIP Comments: Dense vegetation on waterward side limits inspector's inspection. Recommend removing vegetation.					
FIELD_STRUCT_DESC: [Magpie Creek Diversion Plant] 1 of 3: 54-inch steel drainpipe through the levee, 3.0 feet below the crown. Steel cutoff wall around pipe under center of levee. Siphon breaker in protective housing on waterward shoulder. Concrete headwall and flap gate on waterward end. Trench on waterward side. Pumping plant on landward side. (Permit No. 9596-1975)					
FS Date: 12/20/2013

Overview of levee crown.

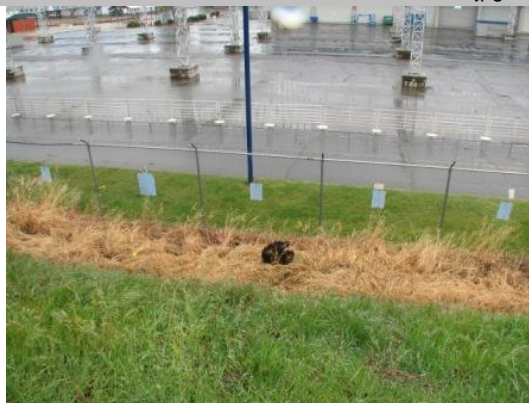
Photo 1 of 1 : mkhashch_s_20140428_00067.jpg

Tree stump on levee slope greater than 2" Dia.

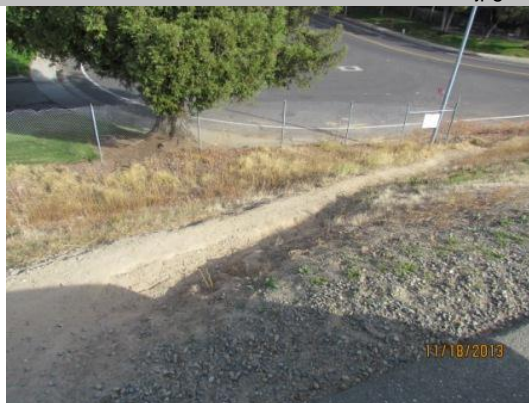
Photo 1 of 1 : mkhashch_s_20140428_00066.jpg

View of the erosion on landside levee slope due to pedestrian traffic.

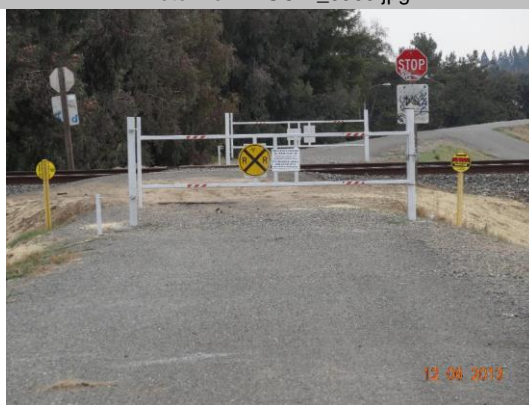
Photo 1 of 1 : UCIP_6360.jpg

Markers visible on waterward and landward shoulders.

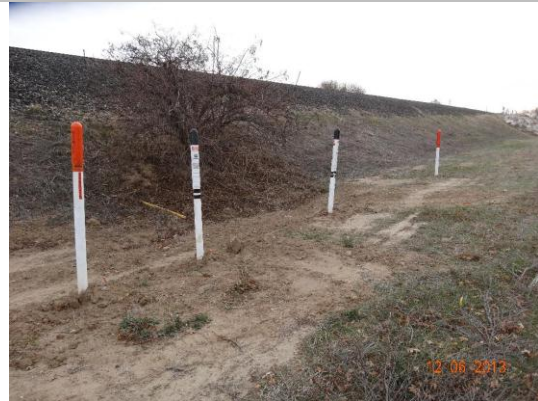
Photo 1 of 1 : UCIP_6237.jpg

Several markers visible on waterward side.

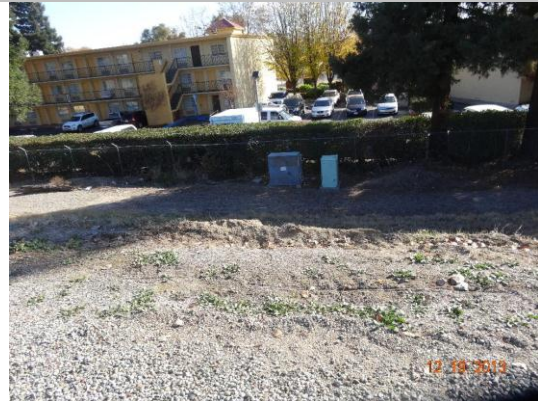
Photo 1 of 1 : UCIP_6189.jpg

View of control panels located on landward side.

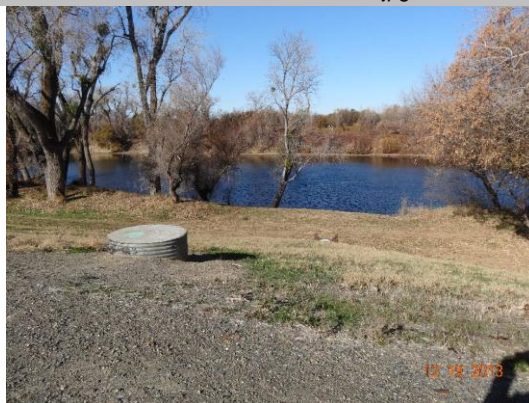
Photo 1 of 1 : UCIP_6364.jpg

View of waterward side--standpipe located on waterward slope.
Standpipe filled with concrete.

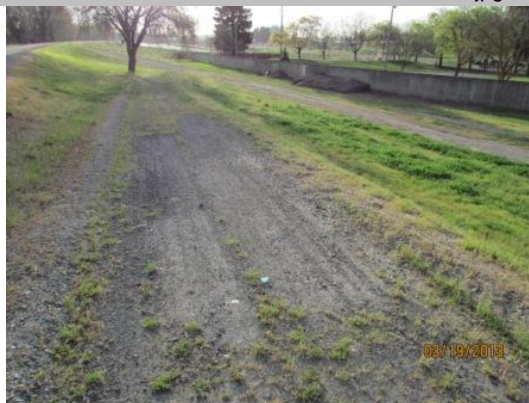
Photo 1 of 1 : mkhashch_s_20140428_00126.jpg

View of improperly graded bicycle ramp.

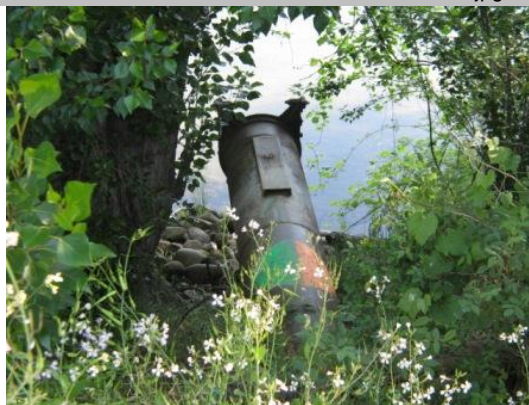
Photo 1 of 1 : mkhashch_s_20140428_00263.jpg

Discharge pipe from printing shop into American River.

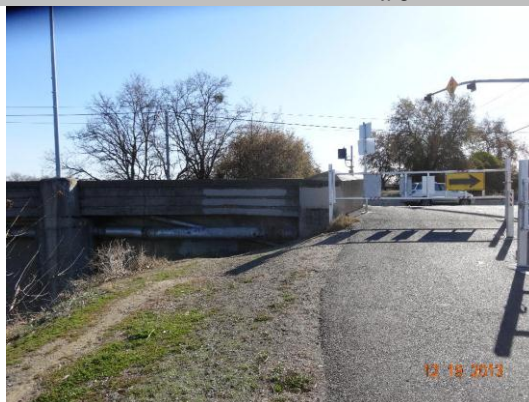
Photo 1 of 1 : UCIP_6191.jpg

View of line exposed at the bridge.

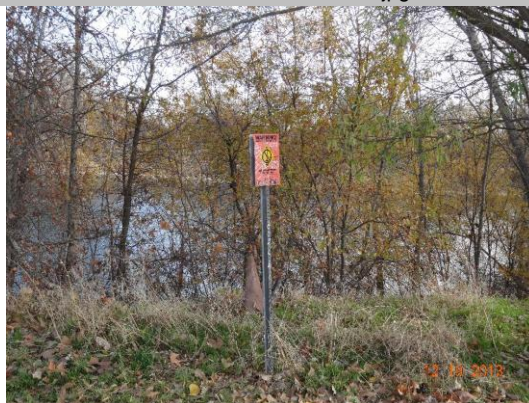
Photo 1 of 1 : UCIP_6247.jpg

Marker for buried fiber optic cable on waterward side.

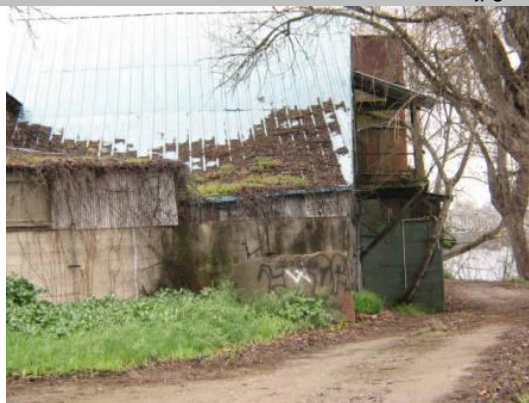
Photo 1 of 1 : mkhashch_s_20140428_00074.jpg

03/16/2012 Structure on Bell Marine property.

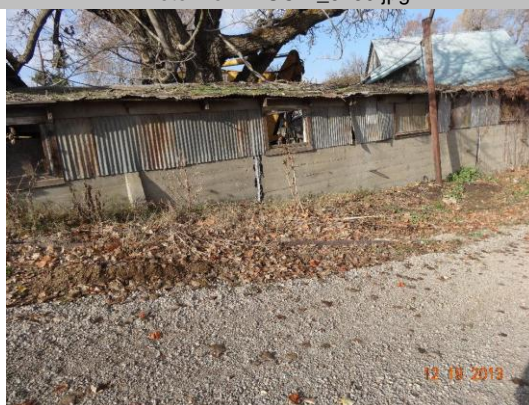
Photo 1 of 1 : UCIP_6250.jpg

View of structure located on levee crown.

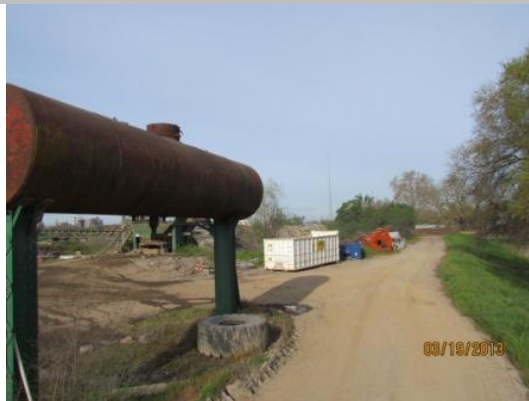
Photo 1 of 1 : mkhashch_s_20140428_00075.jpg

View of the debris obstructing visibility and access.

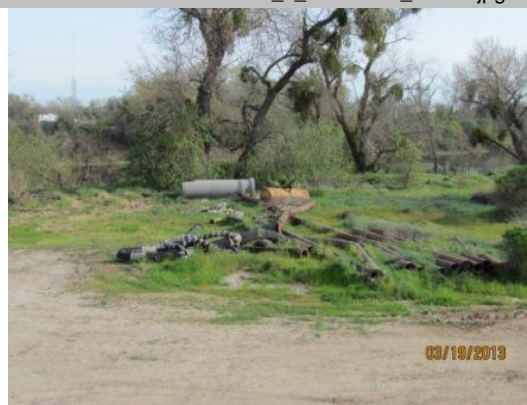
Photo 1 of 1 : mkhashch_s_20140428_00076.jpg

View of the debris stored in floodway.

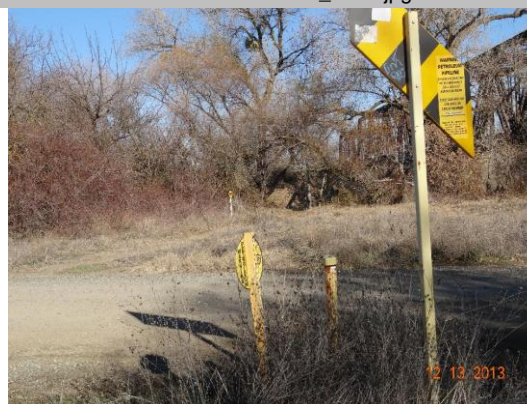
Photo 1 of 1 : UCIP_6307.jpg

View of markers visible on landward side.

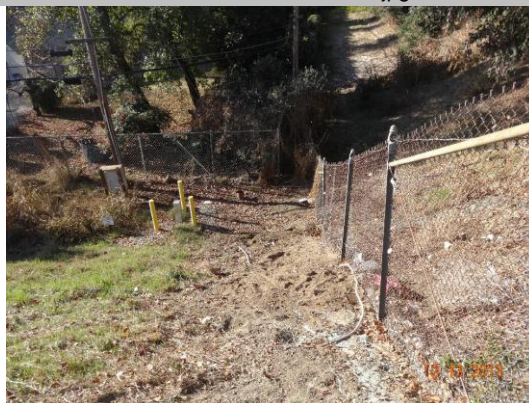
Photo 1 of 1 : UCIP_6253.jpg

Sewer line along fence line on landward side--riser near back fence.

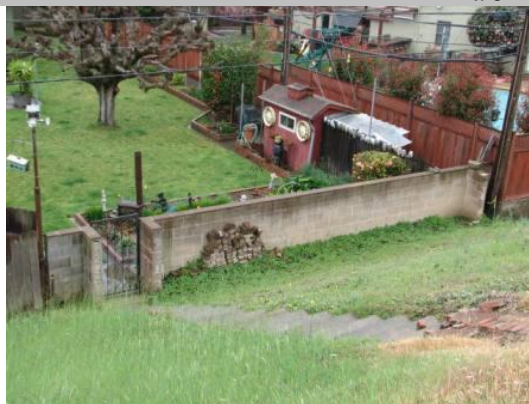
Photo 1 of 1 : mkhashch_s_20140428_00102.jpg

03/16/2012 Cinder block wall obstructs visibility and access.

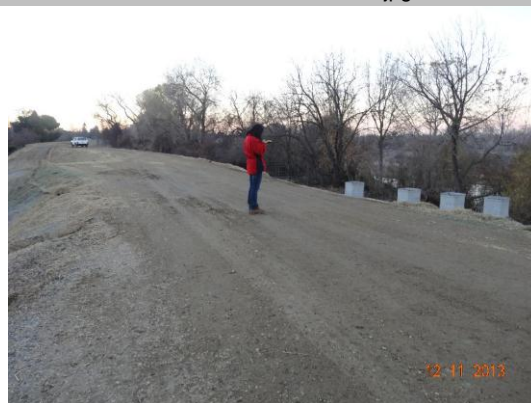
Photo 1 of 1 : UCIP_6424.jpg

View of regraded levee crown with service boxes on waterward slope.

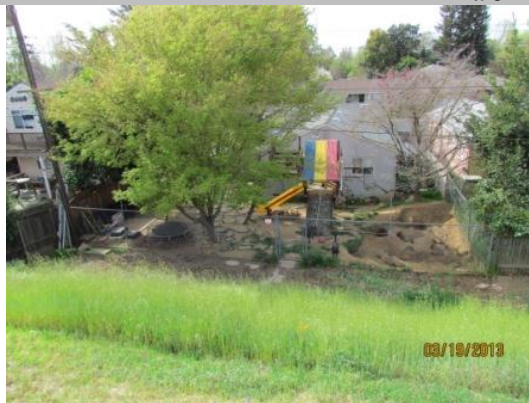
Photo 2 of 2 : mkhashch_s_20140428_00266.jpg

View of the previously noted debris stored in the upstream corner of the property. Note extensive burrowing in the backyard on the downstream (right) corner of the property.

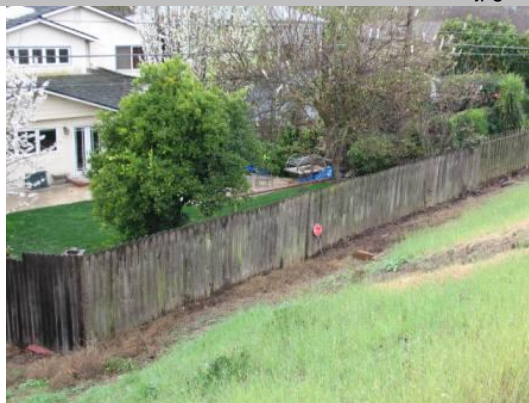
Photo 1 of 1 : mkhashch_s_20140428_00108.jpg

03/16/2012 Wood privacy fence completely obstructs access and visibility.

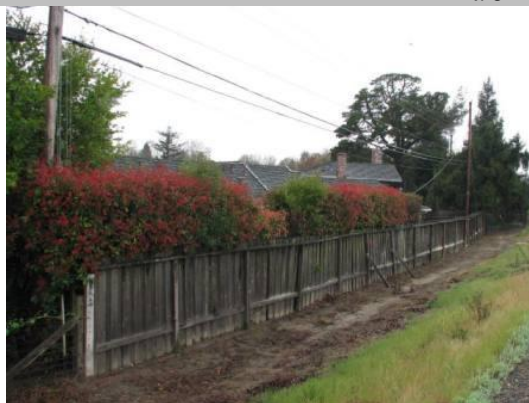
Photo 1 of 1 : mkhashch_s_20140428_00111.jpg

03/16/2012 Wood privacy fence completely obstructs access and visibility.

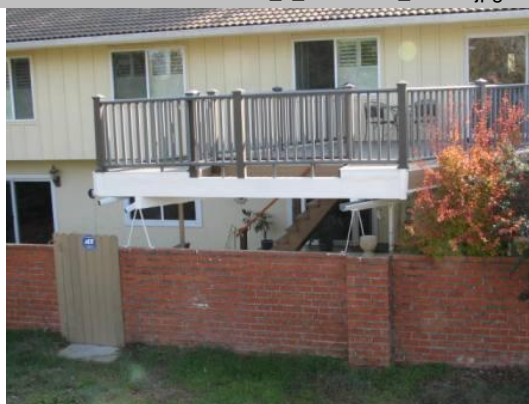
Photo 1 of 1 : mkhashch_s_20140428_00269.jpg

11/15/2011 Gutter drains that are suspended from the balcony direct flow onto the levee toe.

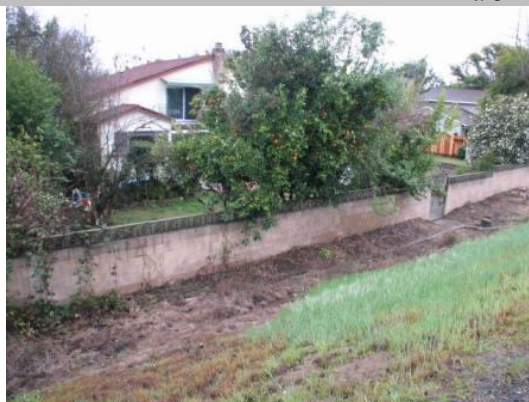
Photo 1 of 1 : mkhashch_s_20140428_00147.jpg

03/16/2012 Cinder block wall completely obstructs access and visibility.

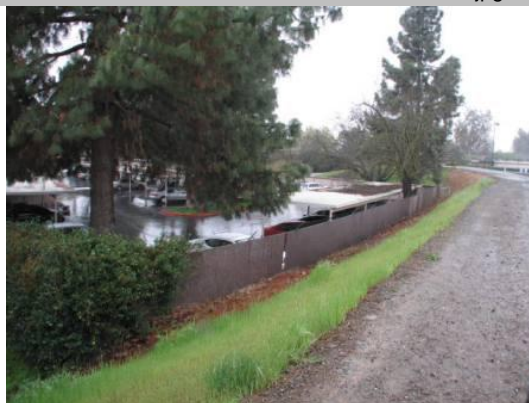
Photo 1 of 1 : mkhashch_s_20140428_00259.jpg

03/16/2012 Chainlink fence with privacy slats and barbed wire obstruct visibility and access.

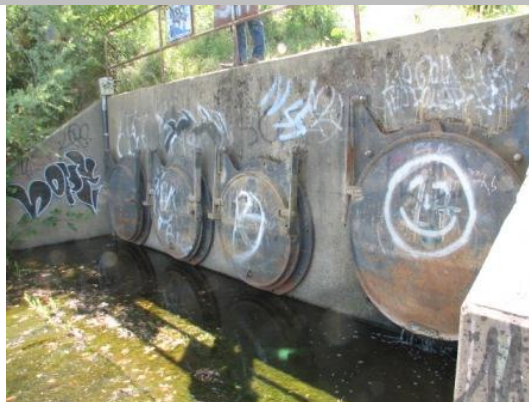
Photo 1 of 2 : mkhashch_s_20140428_00226.jpg

Drainage outfall to American River.

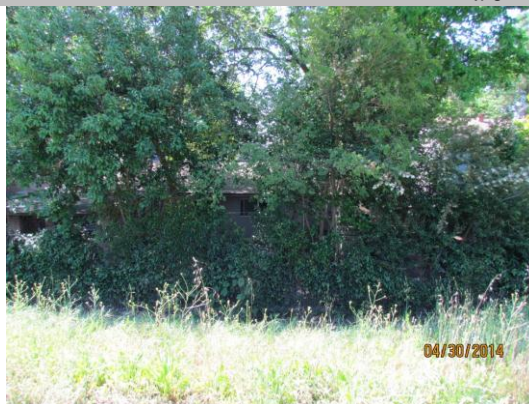
Photo 1 of 1 : mkhashch_s_20140509_00971.jpg

View of the fence at the landside levee toe.

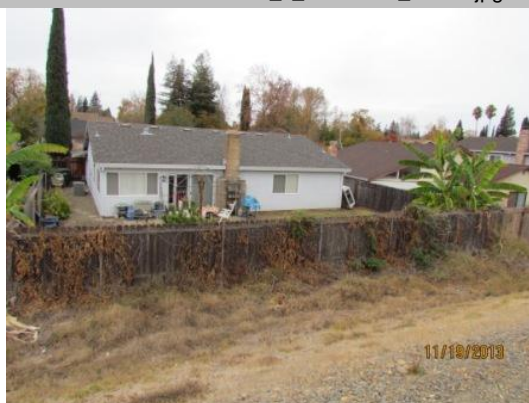
Photo 1 of 1 : mkhashch_s_20140428_00215.jpg

View of wood privacy fence completely obstructing access and visibility.

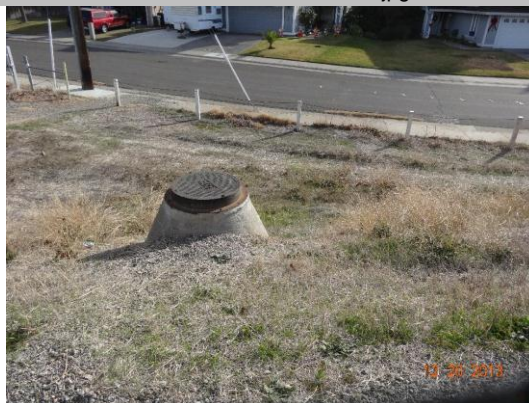
Photo 1 of 1 : UCIP_6303.jpg

Manhole located on landward slope.

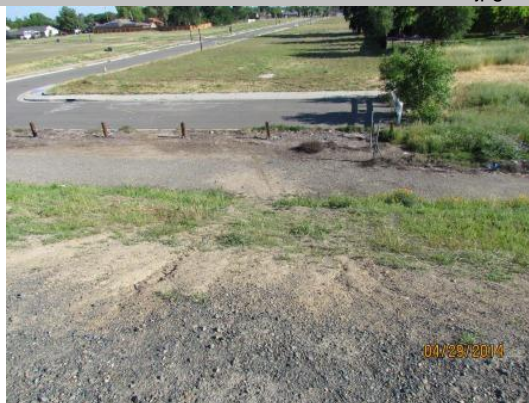
Photo 1 of 1 : mkhashch_s_20140505_00946.jpg

View of the foot traffic on the landside levee toe.

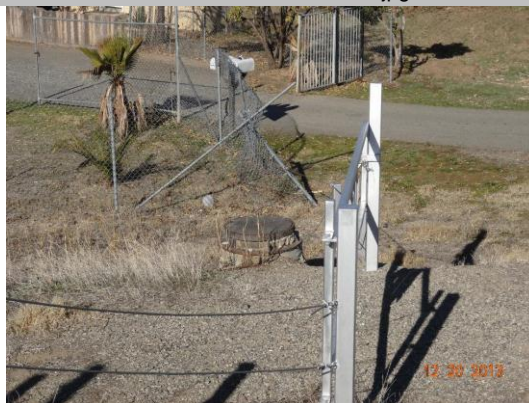
Photo 1 of 1 : UCIP_6203.jpg

Manhole visible on landward side.

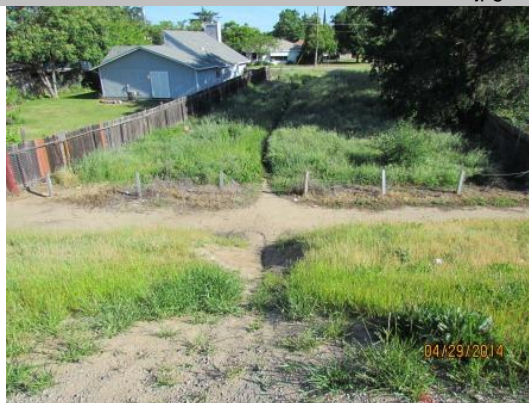
Photo 1 of 1 : mkhashch_s_20140505_00947.jpg

View of the landside levee slope damaged by foot traffic.

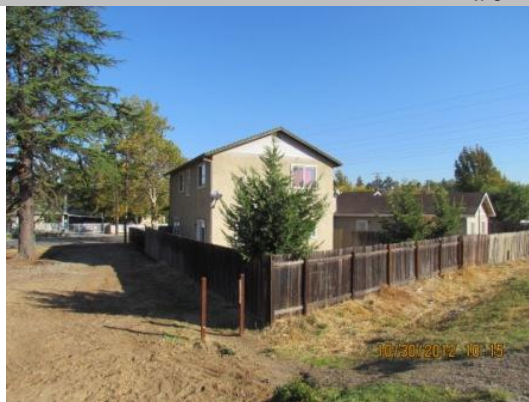
Photo 1 of 1 : mkhashch_s_20140428_00313.jpg

View of wooden privacy fence constructed at the toe.

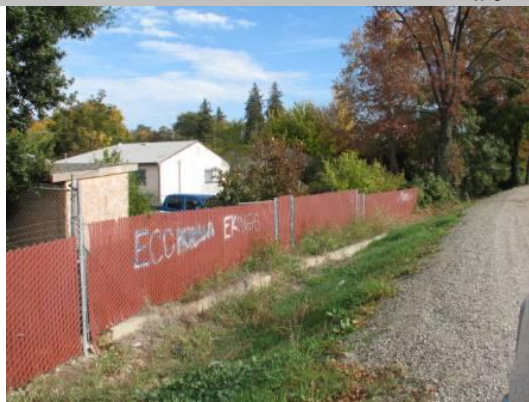
Photo 1 of 1 : mkhashch_s_20140428_00304.jpg

11/17/2011 Privacy fence is located at the toe.

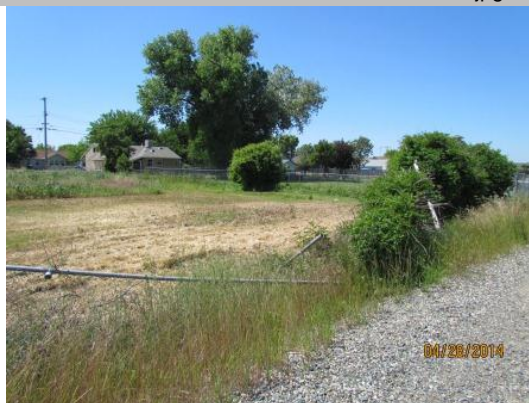
Photo 1 of 1 : mkhashch_s_20140505_00938.jpg

View of the broken fence on landside levee toe.

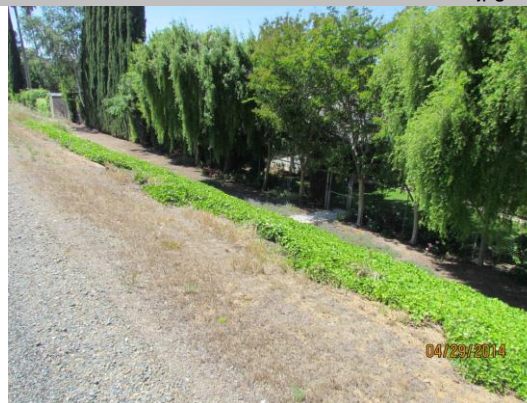
Photo 1 of 1 : mkhashch_s_20140508_00959.jpg

View of the landscaping at the levee toe.

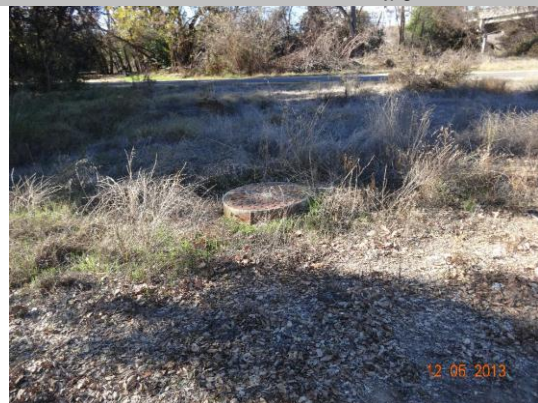
Photo 1 of 1 : UCIP_6402.jpg

Manhole visible on waterward side.

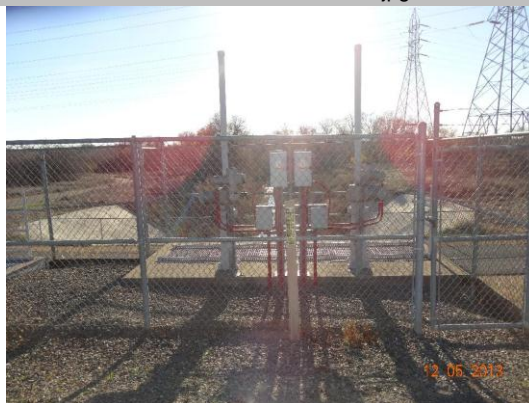
Photo 1 of 1 : UCIP_6385.jpg

Concrete box and electrical box located on waterward shoulder.

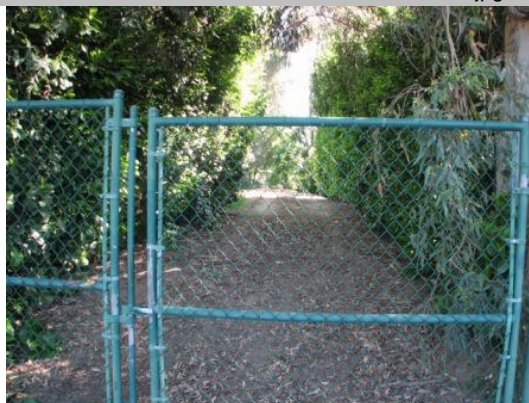
Photo 1 of 1 : mkhashch_s_20140428_00360.jpg

Levee encroached on by property owners north of Arden.

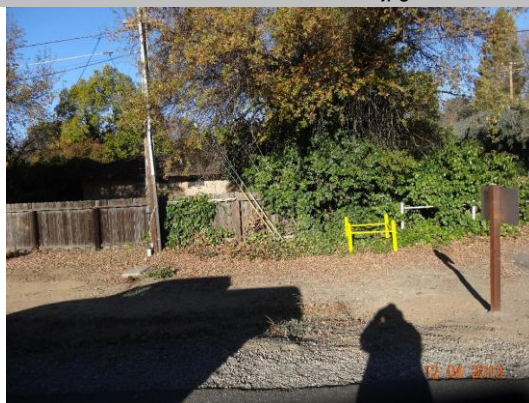
Photo 1 of 1 : UCIP_6435.jpg

View of protective posts located on landward side.

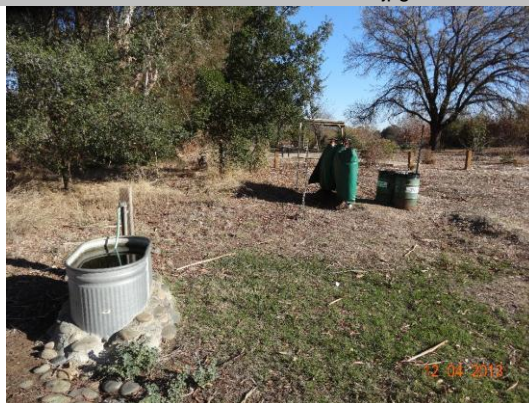
Photo 1 of 1 : UCIP_6102.jpg

View of waterward side--faucet and water flow prevention system.

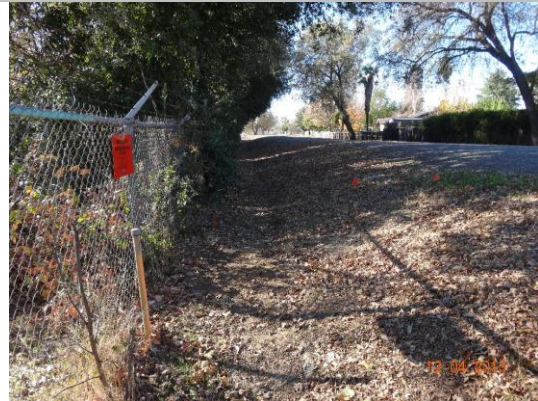
Photo 1 of 1 : UCIP_6114.jpg

View of waterward side--Underground Alert System markers showing alignment.

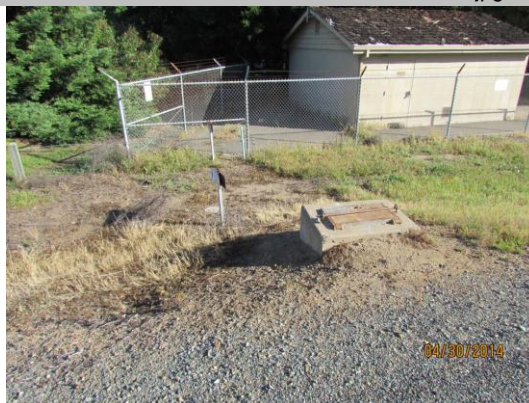
Photo 1 of 1 : mkhashch_s_20140508_00964.jpg

View of the pipe at the landside levee hinge.

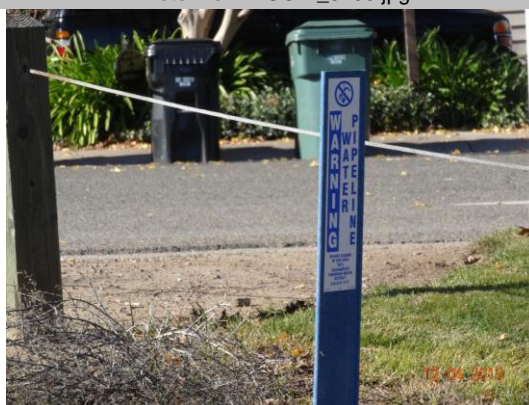
Photo 1 of 1 : UCIP_6296.jpg

Waterline marker at levee mile 1.63.

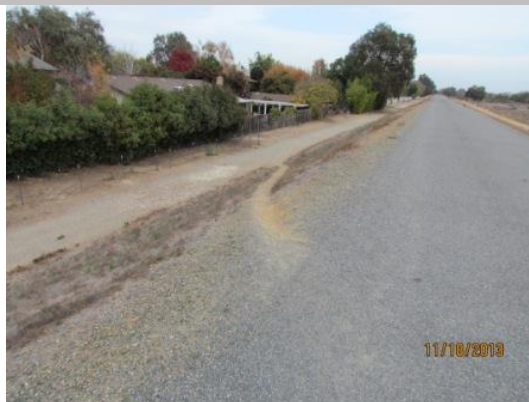
Photo 1 of 1 : mkhashch_s_20140428_00359.jpg

View of the pathway on the landside levee slope.

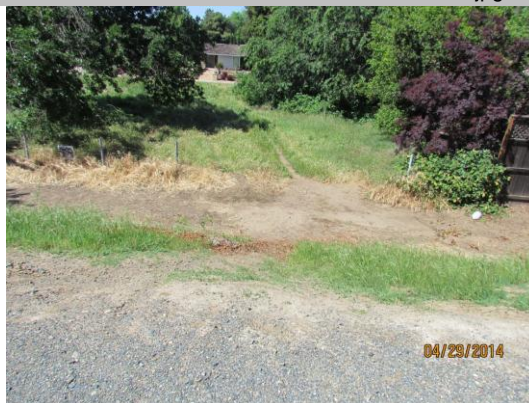
Photo 1 of 1 : mkhashch_s_20140508_00963.jpg

View of the erosion on the landside levee slope caused by pedestrian foot traffic.

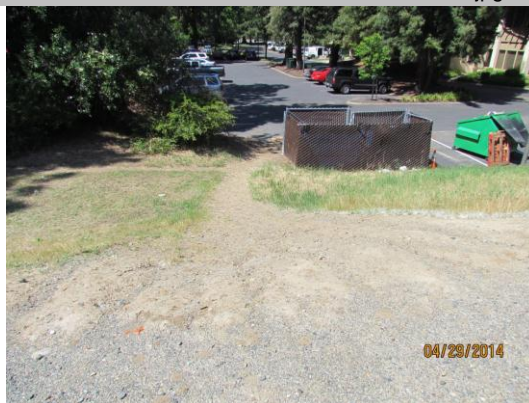
Photo 1 of 1 : mkhashch_s_20140508_00962.jpg

View of the erosion on the landside levee slope caused by pedestrian foot traffic.

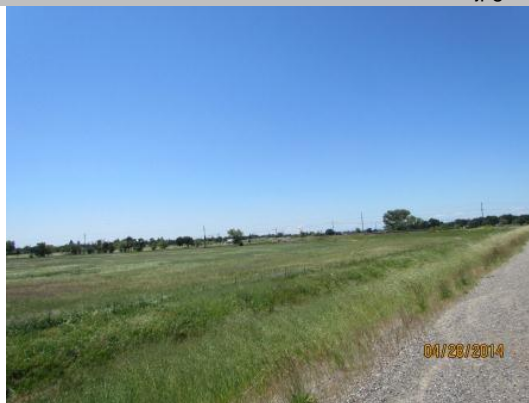
Photo 1 of 1 : mkhashch_s_20140505_00939.jpg

View of the tall vegetation on the landside levee slope.

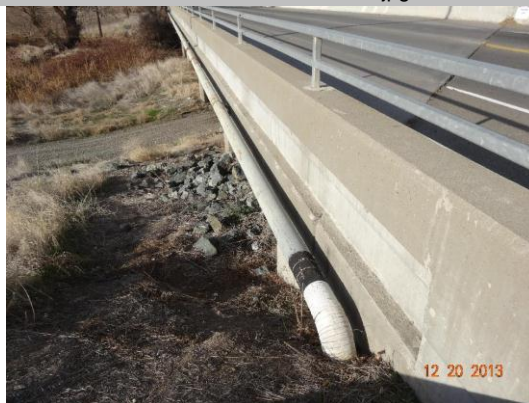
Photo 1 of 1 : UCIP_6409.jpg

Crossing visible on waterward side.

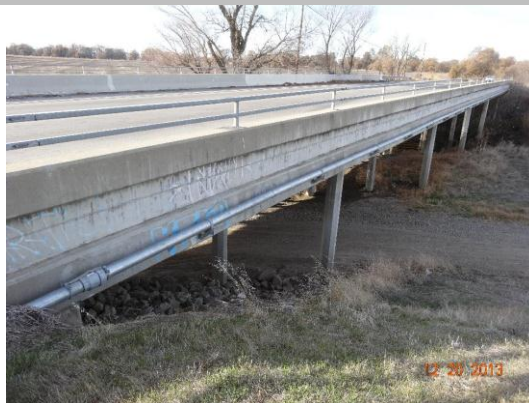
Photo 1 of 1 : UCIP_6410.jpg

Conduit attached to the upstream face of Rio Linda Blvd Bridge.

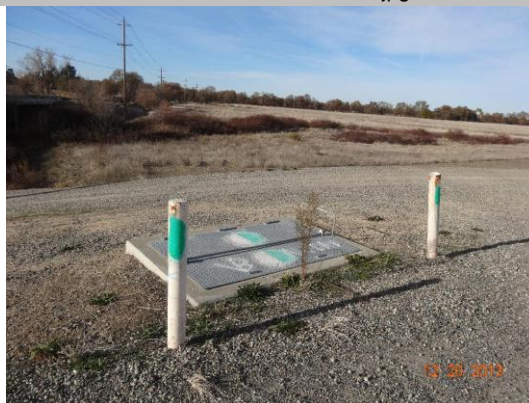
Photo 1 of 1 : UCIP_6412.jpg

Concrete vault with protective posts located on waterward shoulder.
